SEVERE MARINE ATMOSPHERE (CHLORIDE PITTING)

STAINLESS STEEL FOR SEVERE MARINE ENVIRONMENTS

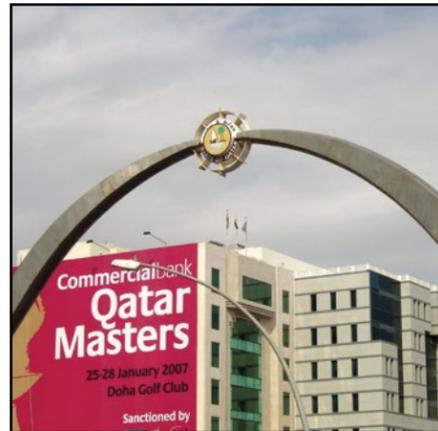
Photo G: Downtown Doha Arch, Qatar

Middle Eastern environments will be a challenge to T316L stainless as well as painted aluminum, as suggested in the accompanying table outlining conditions in Doha and Jeddah, where corrosion of T316 stainless steel has occurred. These environments are similar to elevated temperature, salt fog chambers with little or no rinsing. We have three informal reports on red rust pitting corrosion of T316L after short exposure in that region. First, in Saudi Arabia on the Red Sea (see Photo F), exterior panels made of Type 316L #4 Stainless Steel began corroding shortly after installation. In addition, a Doha, Qatar window trim installation experienced a similar result (the structure is not directly on the Persian Gulf coast.) The third example is an arch in downtown Doha, comprised of crossing swords that span a city street. The arch, which exhibits visible rust, is reportedly made of Type 316 stainless steel (see Photos G & H).

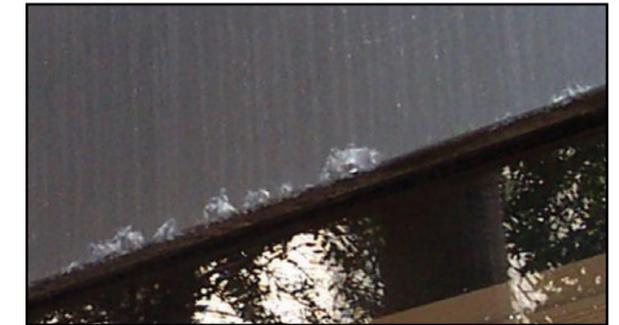
A real world example of a painted aluminum failure appears in Photo I (below). These painted aluminum panels were installed in 1982 when this Tampa, FL building was constructed. This photograph, taken 20 years later, shows complete perforation. We theorize that crazing of the paint layer at the bend radius of the panel (which normally occurs during fabrication) provided enough opportunity for chlorides (from the marine environment) to find crevices in which to reside, propagating rapid corrosion.

Photo I: 20 Yr. Old Painted Aluminum Panels - Tampa, FL

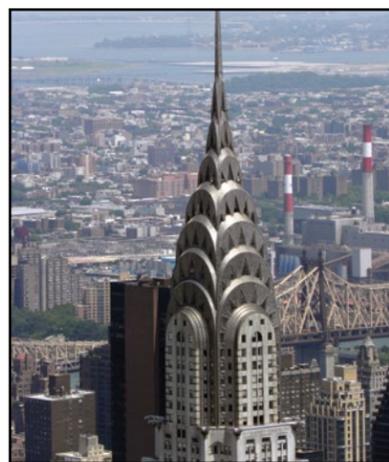
Photo J: Chrysler Building - New York

be more costly on a life cycle basis. In contrast, ATI 2003™ InvariMatte® stainless steel can be expected to last the useful life of a building in a severe marine environment with little maintenance (clear gutters and wash panels for cosmetic reasons). Stainless steel's longevity is exemplified by the domed roof of the Chrysler Building in New York (Photo J), which has stood the test of time. Made of stainless steel, it is still in service after 77 years, having been cleaned only twice.
